# VEHICLE INSPECTION REPORT

**PJ71DTK**

## Mercedes-Benz Sprinter 317 2.0 TDI

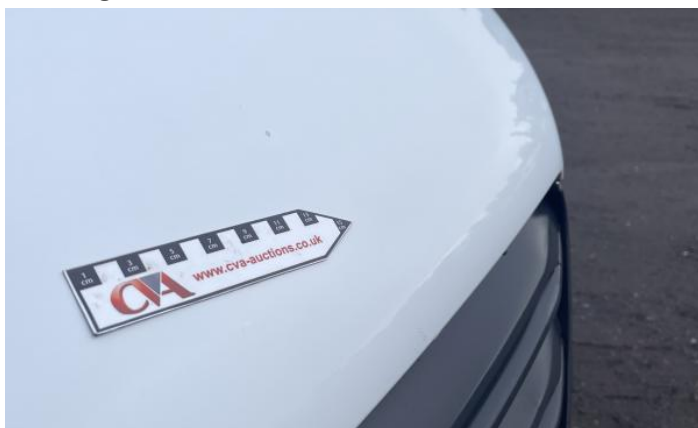
1: Bonnet  
Dented  
Over 30mm

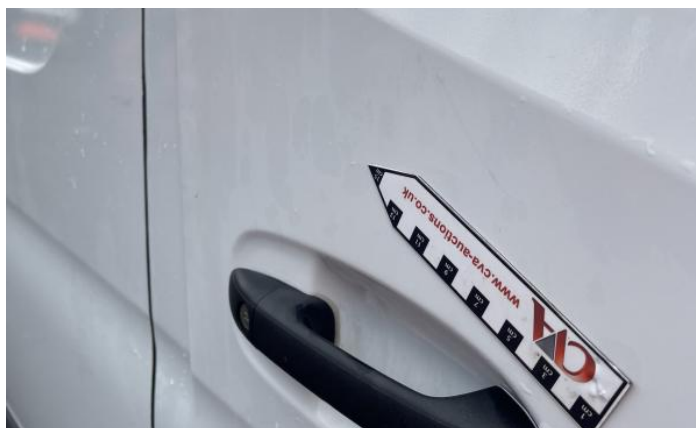
2: Door osf  
Dented  
Over 2 UpTo 10mm

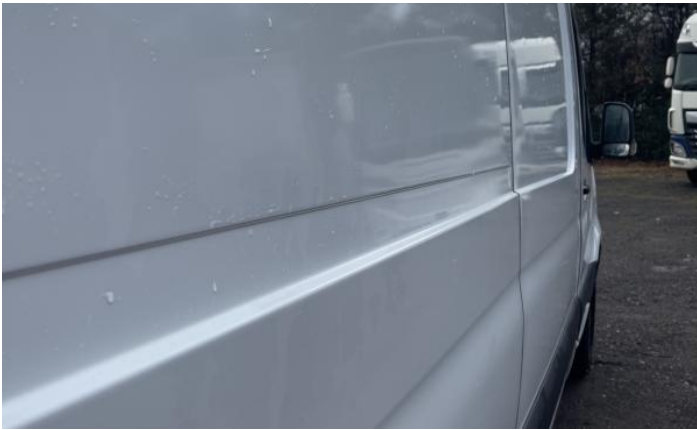
3: Qtr Panel osr  
Poor Previous Repair  
Rippled UpTo 30%

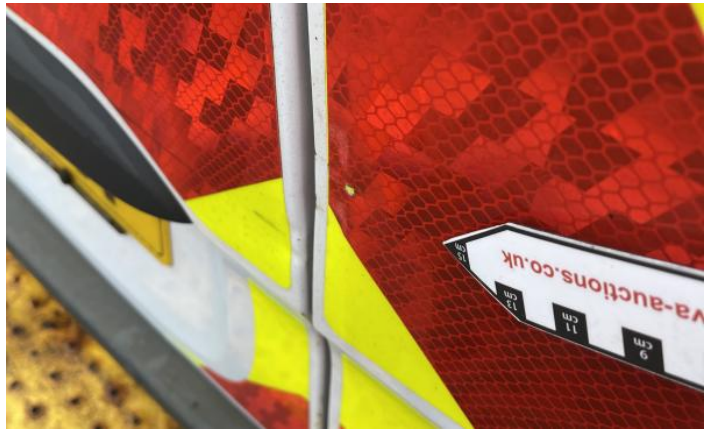
4: Tailgate  
Dented  
Over 30mm

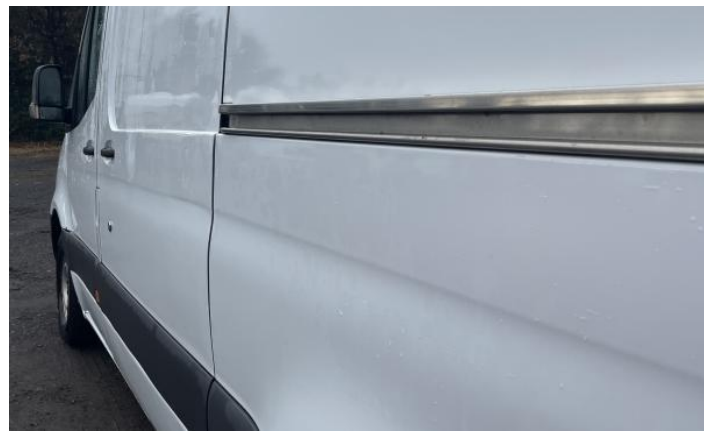
5: Qtr Panel nsr  
Poor Previous Repair  
Rippled UpTo 30%

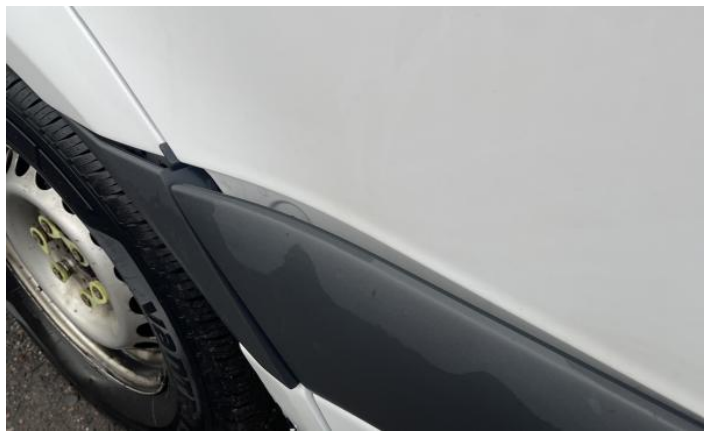
6: Door Moulding nsf  
Broken  
Replace
