VEHICLE INSPECTION REPORT

KP19SNB

Mercedes-Benz Sprinter 314 CDI

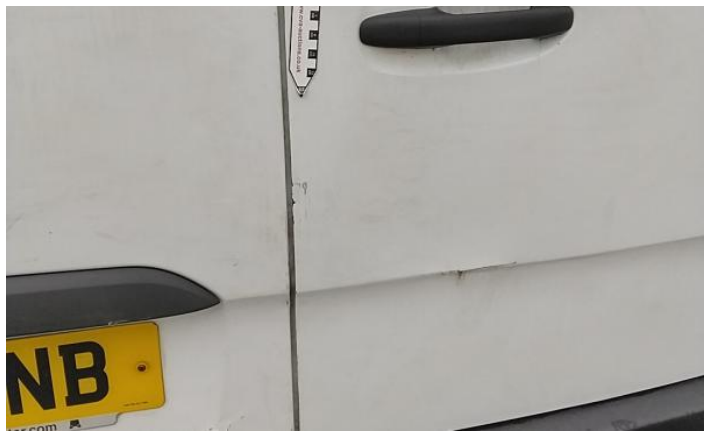
18: Door osr
Dented
With Paint Damage

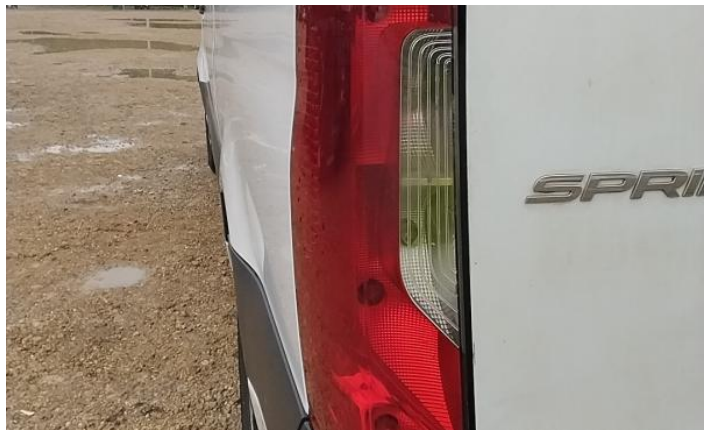
20: Lamp nsr
Broken
Replace

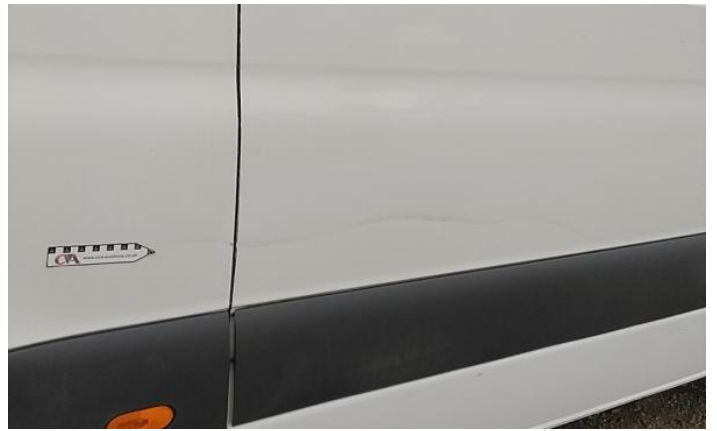
24: Qtr Panel osr
Scratched
Over 25mm Thru Paint

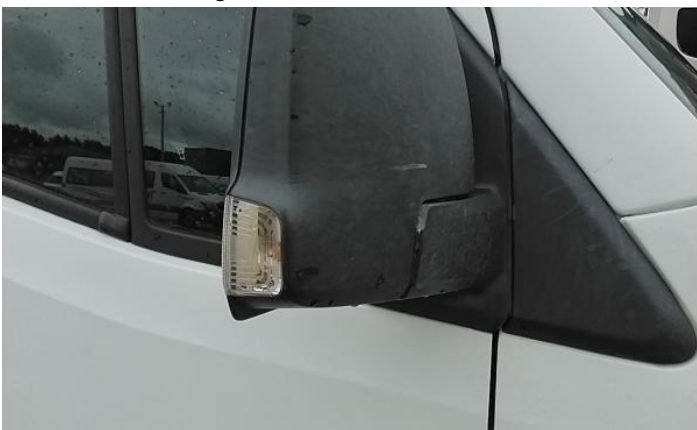
25: Door Mirror Assy osf
Scuffed (Unpainted)
UpTo 100mm

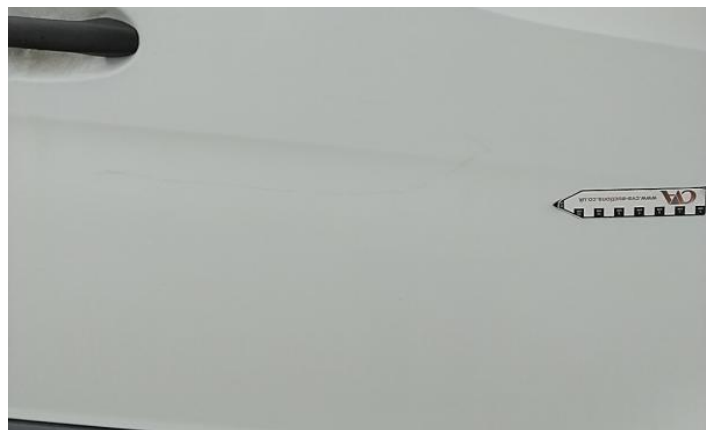
26: Door osf
Scratched
Over 25mm Thru Paint
