# VEHICLE INSPECTION REPORT

**MXZ7282**

## Scania R 450

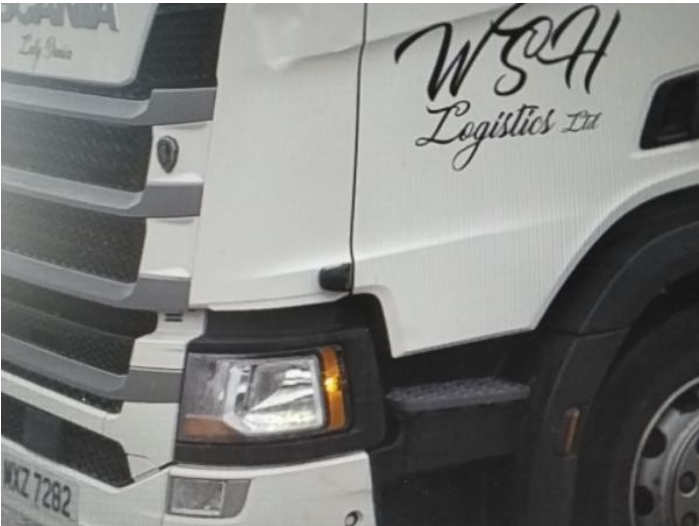
1: A Post ns  
Dented  
Over 30mm
