VEHICLE INSPECTION REPORT

SL75YPX

Ford Transit Custom 320 65KWH Sport

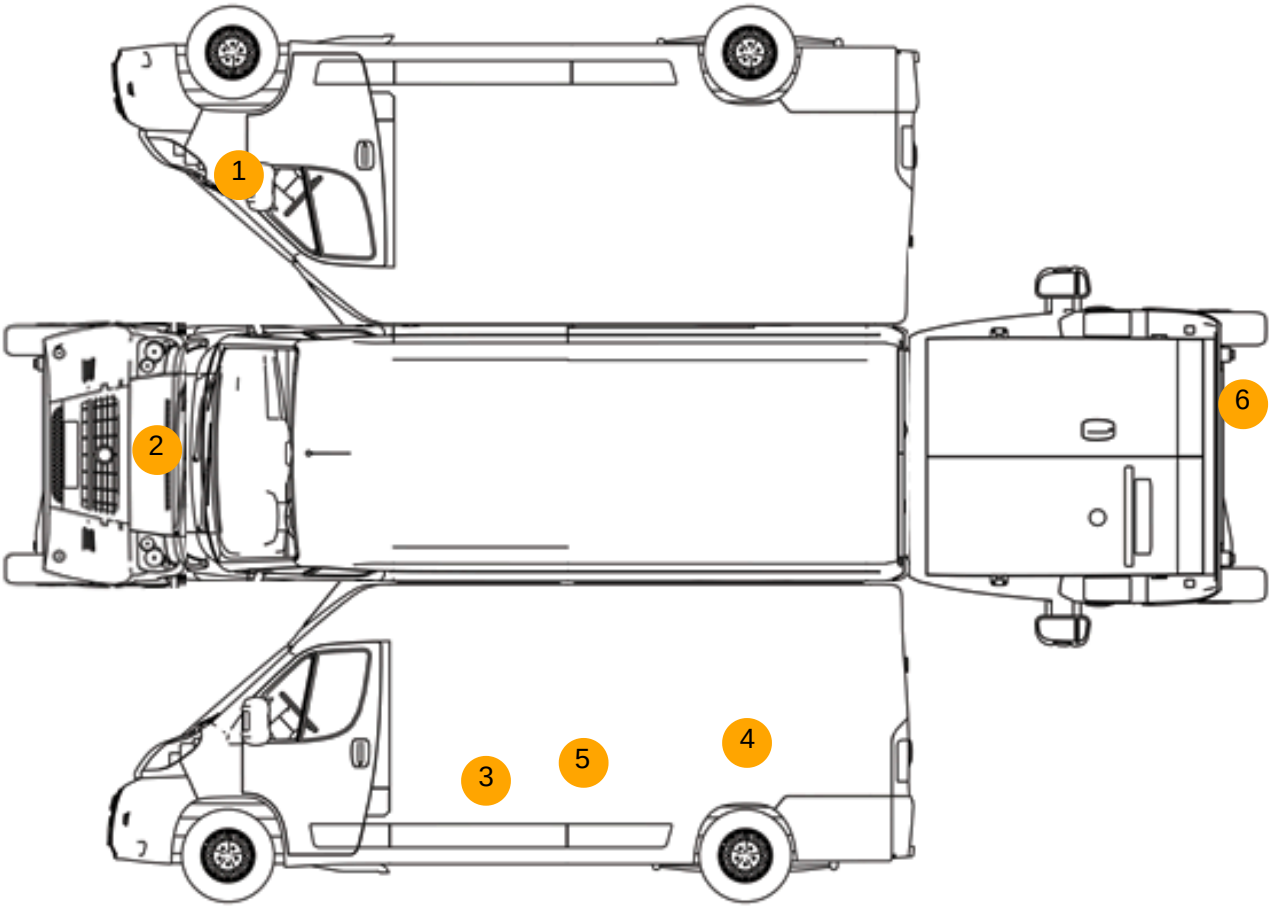
1: Wing osf
Chipped
1 To 5

2: Bonnet
Chipped
Multiple Chips

3: Door nsr
Chipped
Edge Chip

4: Qtr Panel nsr
Cracked
Replace
Missing clips holding to body so it’s loose

5: Qtr Panel nsr
Scratched
Over 25mm Thru Paint

6: Bumper Rear
Scratched
Over 100mm Thru Paint
